Safety Memorandum

To: All personnel
From: Engine Co. 1/Battalion #2
(Lt. xxxxxx, FF xxxxxx)
Date: XXXX
Ref: Potential Forcible Entry/Egress Problem
@ XXXX NoName St

**NoName Store, XXX NoName Street, Concord, NH
Side C Door**

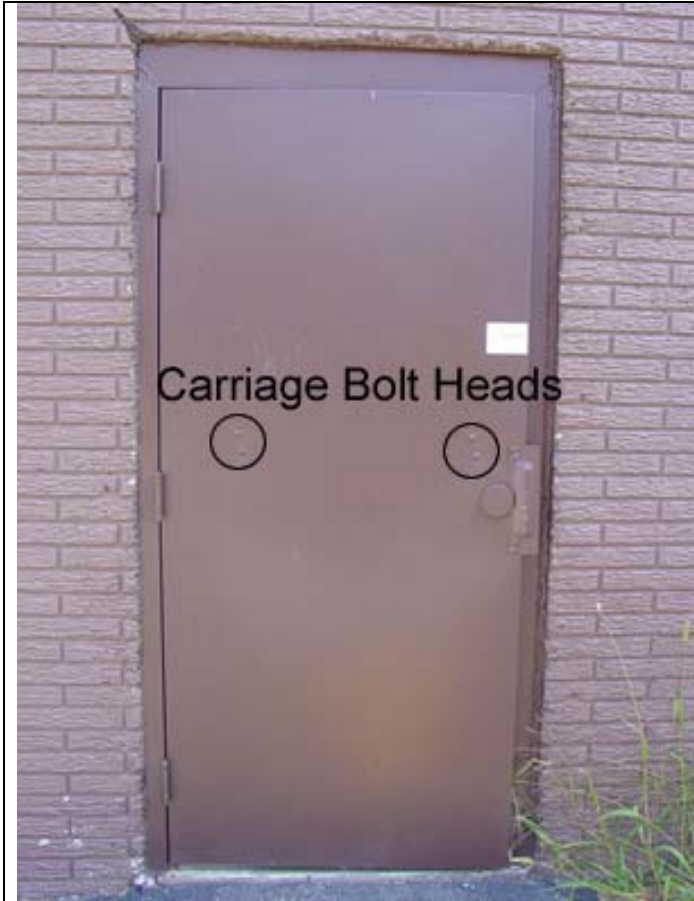
Exterior view with door closed. Note 4 visible carriage bolt heads, indicating the possible presence of a door bar. Also note the lack of exterior doorknob and added strike plate protection.

From a forcible entry perspective, the most efficient way to force this door will be to use a circular saw with metal cutting blade to remove a large triangle from the center of the door, and then attempt to remove the door bar and unlock the cylinder lock on the lockset through the hole. It may also be possible to cut the door bar in half with the saw, if it is not easily dislodged by hand. Traditional forcible entry methods can then be applied at the top and bottom of the door to force the barrel bolts.

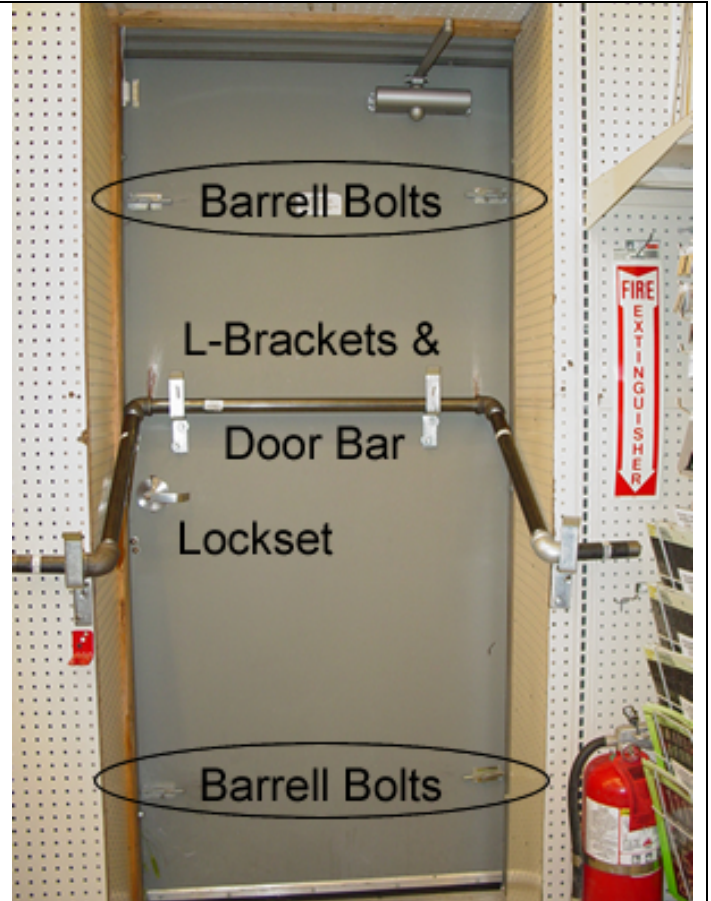
Interior view with door secured. Note 4 barrell bolts and iron pipe door bar in position. This door bar can only be removed at one specific angle due to the approx. 16-inch thick walls.

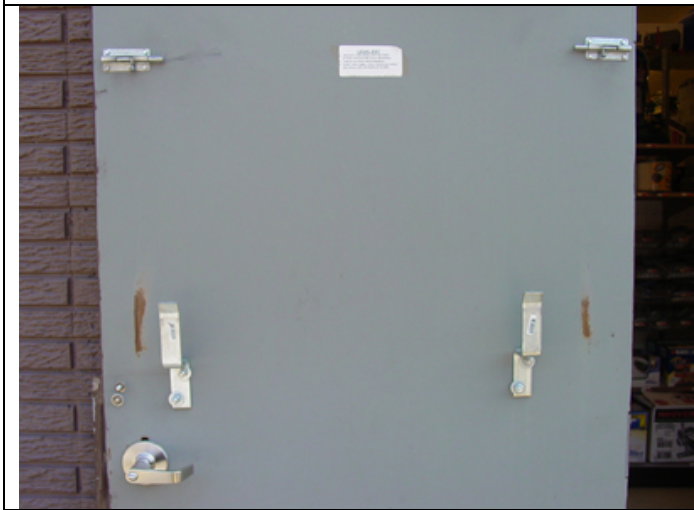
Detail of door without security devices installed.

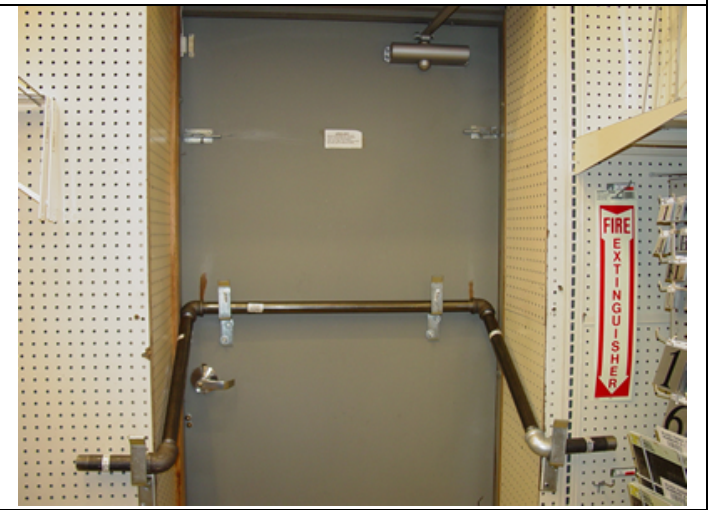
- The original lockset and door handle has been removed and replaced with an interior-only type lockset
- An exterior security plate has been added over the strike-plate area
- A barrel-bolt has been added in each corner of the door (total 4 additional locks) approximately one foot up from the bottom or down from the top of each corner of the door
- L-brackets have been carriage bolted to the center of the door and to the wall on either side of the door. Rather than the traditional 2 x 4 wooden door bar, the occupants have fabricated a very elaborate door-bar system out of schedule 40 black iron pipe. The door-bar is not only very heavy and strong, but also only slides into and out of its brackets at one specific angle.

Detail of door with security devices installed.
